Refineries and Associated Plant: Three Accident Case Studies

This note presents a brief overview of refineries and their accident record, followed by three accident case studies:

1. A pipeline rupture and fire in Washington State, USA, on 10th June 1999.
2. An accident at the coking plant of the Anacortes refinery, Puget Sound, Washington State, USA, on 25th November 1998.
3. The BP Texas City refinery fire and explosion on 23rd March 2005.

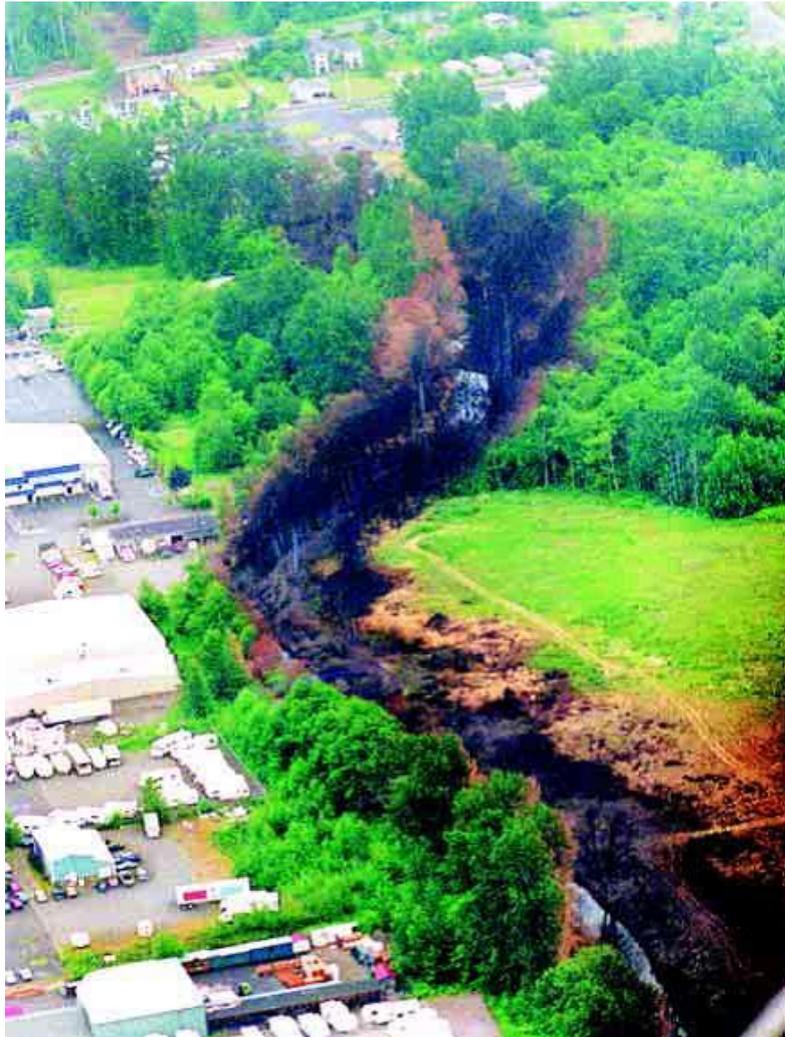
This accident involved the rupture of a buried gasoline (petrol) pipeline.² The basic facts are simple yet tragic. The buried pipeline was 16 inches in diameter (40 centimetres), and the rupture released about 237000 gallons (more than a million litres) of gasoline into a river creek flowing through Whatcom Falls Park in Bellingham, Washington. The park is a woodland area in an otherwise mostly residential suburb, a few miles south of the US-Canadian border.

The gasoline from the pipe flowed down the river creek for about 90 minutes before finding a source of ignition and catching fire. One and a half miles of the river creek burned, and two ten-year old boys and an eighteen-year old man were killed, with a further eight people injured. Property damage was estimated at \$45 million.

Fig 1: Whatcomb Falls Park, June 1999, after the fire in the river creek (NTSB)

(After the accident, inspection of the failed section of pipeline showed “numerous gouges and dents”. The pipeline was about 10 feet (3 metres) underground at the failure location. The failed section of pipe had a tear-like fracture some 27 inches (68 centimetres) long with a maximum separation of 7 inches (17 centimetres).)

This pressure pulse went through the system; the SCADA system was unresponsive, so the isolating valves did not operate; and the pipe ruptured at 1528 hours, at the point where a defect remained from the 1994 excavation work.

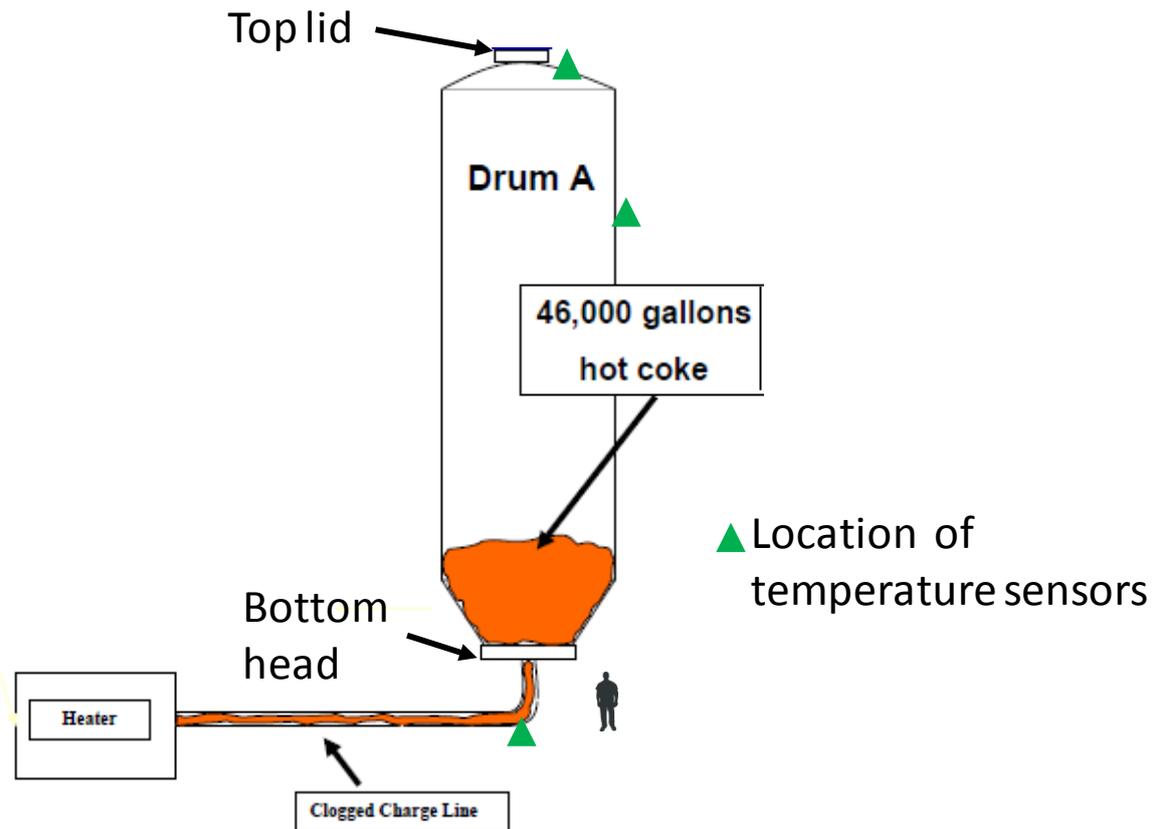
In this case, however, because of the power interruption, the Charge Line at the bottom of the vessel, through which the coke would normally flow out of the drum at the end of the cycle, was clogged with coke that had formed during the power cut. This meant that the operators were unable to put steam or water into the drum to cool the coke. There were some 46000 gallons (about 200 m³) of hot coke remaining in the drum.

Fig 2: Drum A in the coking plant at Equilon Anacortes refinery, 25th November 1998. Six people standing under the bottom head when it was unbolted and removed were killed by hot coke and burning heavy oil residue.

The six workers killed in the explosion were two Equilon employees and four Western Plant Services employees. They died from smoke inhalation and burns.

Equilon subsequently installed a remotely-controlled system for removing the drum lids, and installed a gas-fired back-up system to maintain steam supplies in the event of a power failure.

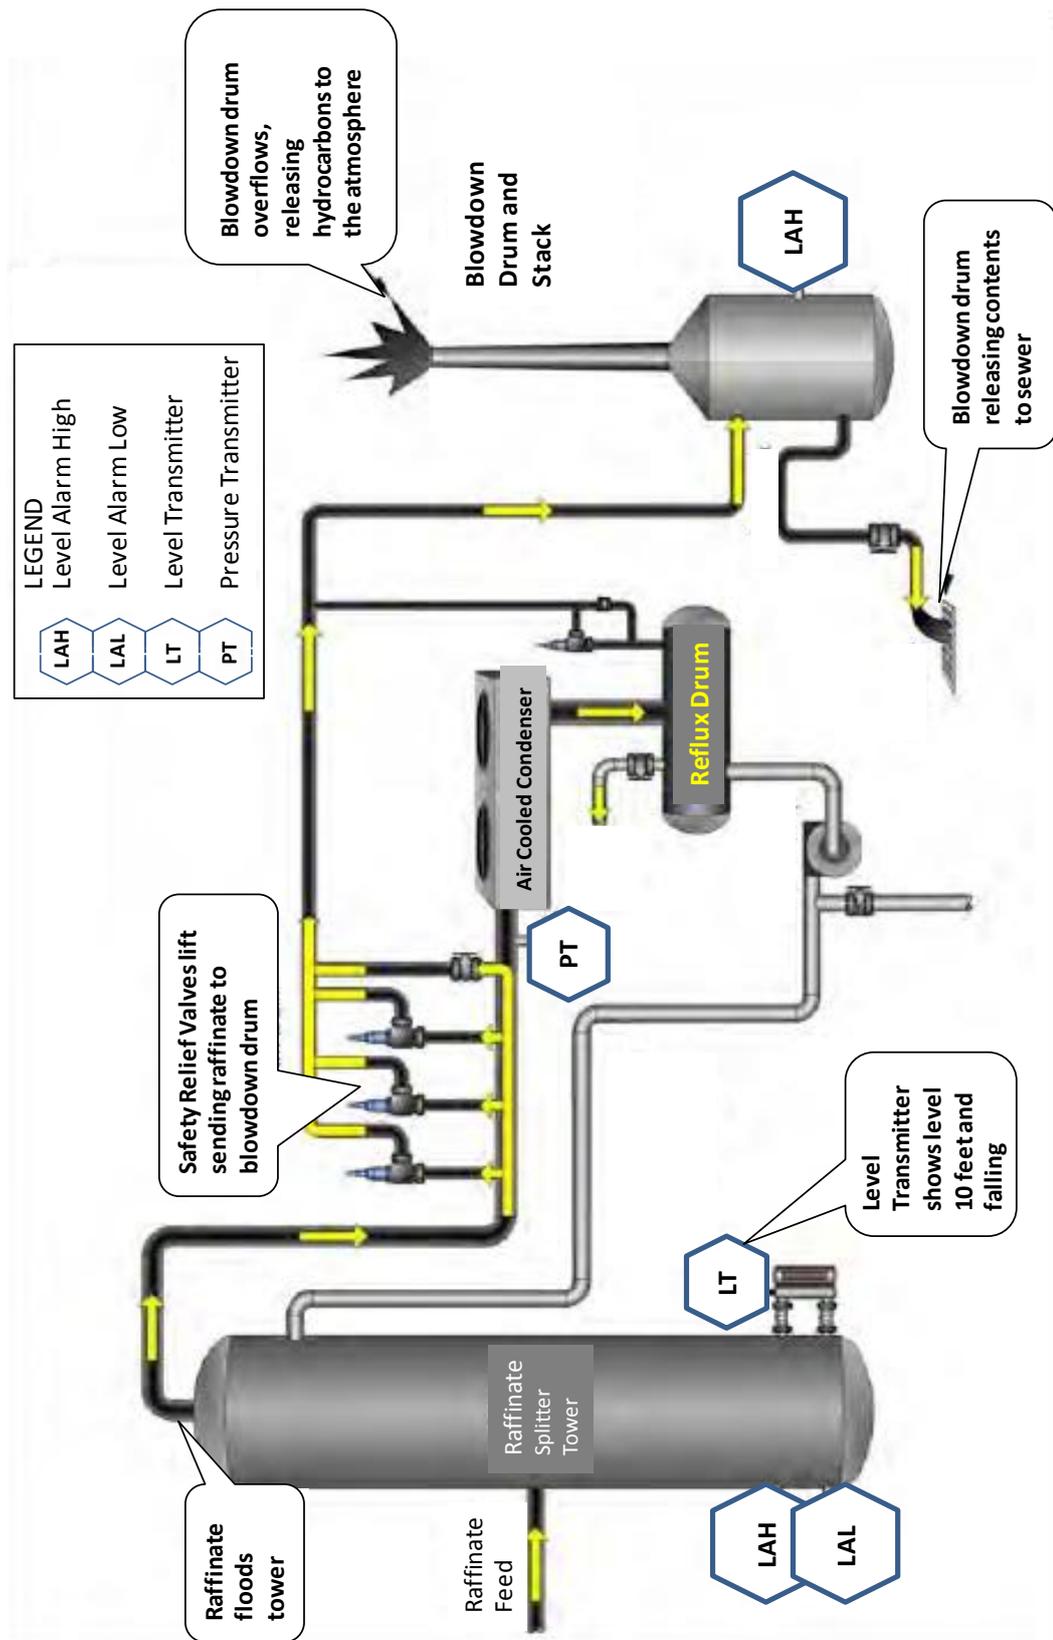
At 0215, operators started to introduce raffinate⁸ into the Raffinate Splitter Tower, which is used to distil and separate gasoline components. The tower was more than 30 metres tall. A single instrument (shown as LT) was available for liquid level indication at the bottom of tower which had a maximum indicated level 9 feet (about 3 metres). Above this level the instrument just indicated ‘9 feet’. However, operators routinely filled above level this during start-ups to avoid the possibility of low level causing furnace damage.

At 0309, a High Level Alarm (shown as LAH) actuated. Another alarm, designated ‘Hi-hi’, failed to actuate.

Fig 3: Schematic diagram of the Isomerisation Unit, BP Texas City (adapted from the US Chemical Safety and Hazard Investigation Board report)

At 1314, the hot feed raffinate caused boiling, so the level rose until the Splitter Tower was filled completely. Hot liquid gasoline then spilled into the vapour line, which caused pressure relief valves in the vapour line to open (*see Figure 3*). 52000 gallons (236000 litres) of liquid gasoline thereby vented to the blowdown drum, where it overflowed and drained into a process sewer, setting off

control room alarms. The high-level alarm in the Blowdown Drum (shown as LAH) failed to actuate. A geyser of liquid and vapour gasoline erupted from the vent above the Blowdown Drum, and the hot gasoline formed a large vapour cloud, which was ignited by a running truck engine nearby. An explosion and fire ensued, causing 15 deaths and 180 injuries. The temporary trailers housing the contractors were destroyed in the blast.

To recap: The accident involved the Splitter Tower becoming completely filled with hot liquid raffinate (naphtha or gasoline), when it should have been less than one-tenth full. Hot raffinate then overflowed into the Blowdown Drum and out through its vent. The Splitter Tower had been receiving raffinate feed for several hours without any apparent concern that it might be overflowing. The level instrumentation at the bottom of the tower never recorded any values above about 9 feet. After the overflow, the Blowdown Drum level alarm failed to work.
