Kashiwazaki–Kariwa, IC failure due to electro migration

Source: NUREG/CR-6842, Advanced Reactor Licensing: Experience with Digital I&C Technology in Evolutionary Plants, NRC 2004

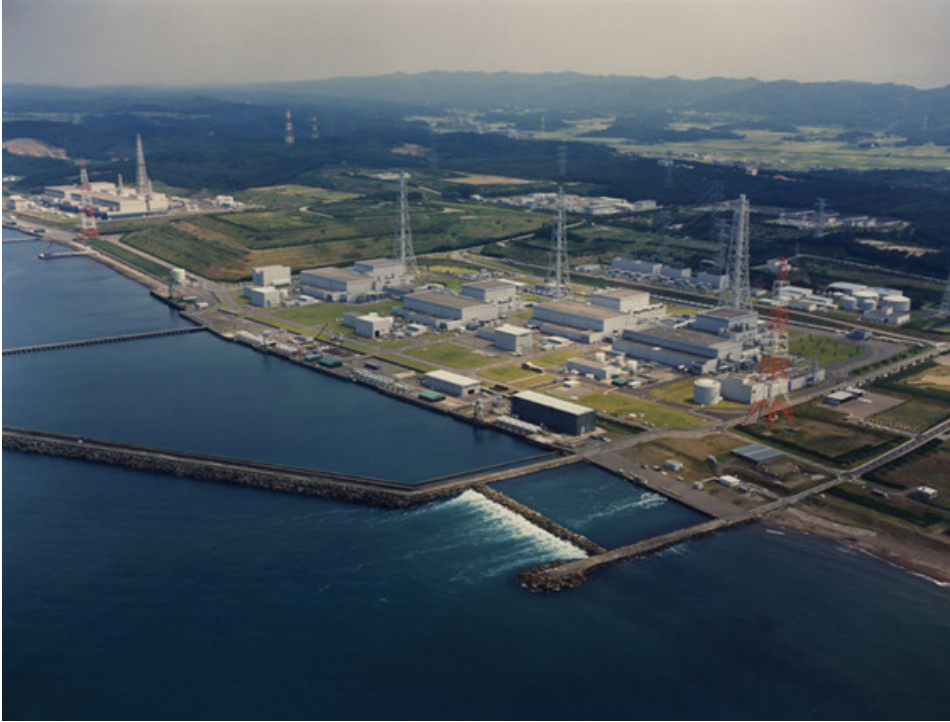
In 2001 a failure of control rod transponder circuit boards at Kashiwazaki-Kariwa Nuclear Power Station Unit 5 (Japan) rendered the control rods inoperable. Following detection of the defective cards, an analysis revealed that the failure mechanism was aluminium wire breakage in the ICs caused by electro migration (the transport of metal atoms induced by high electric current). Aluminium grain size was too small which increased susceptibility to electro migration. The affected ICs had been manufactured between 1985 and 1990.

Failure analysis methods and manufacturing quality control and testing have been improved. This effect is potentially more significant in more modern ICs where the level of miniaturisation is much greater.
