## Situation Awareness and the Human-Machine Interface

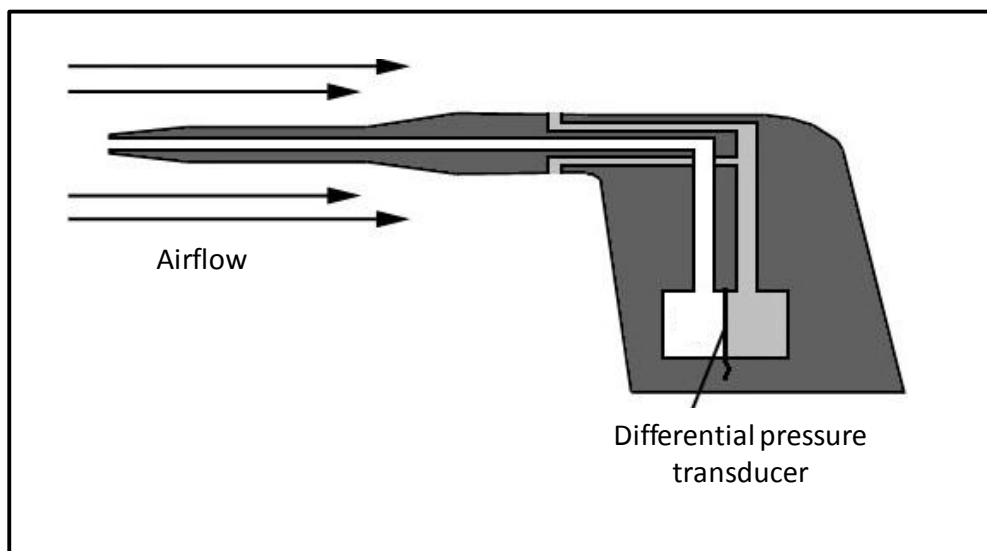
Fig 1 Pitot tube

Subsequent investigations of the aircraft wreckage could find no blockages in the Pitot tubes. However, there was a known problem at Puerto Plata airport with a particular species of wasp, the mud dauber wasp, which may have built nests inside the Pitot tubes during the aircraft's three-week stay on the runway at Puerto Plata.

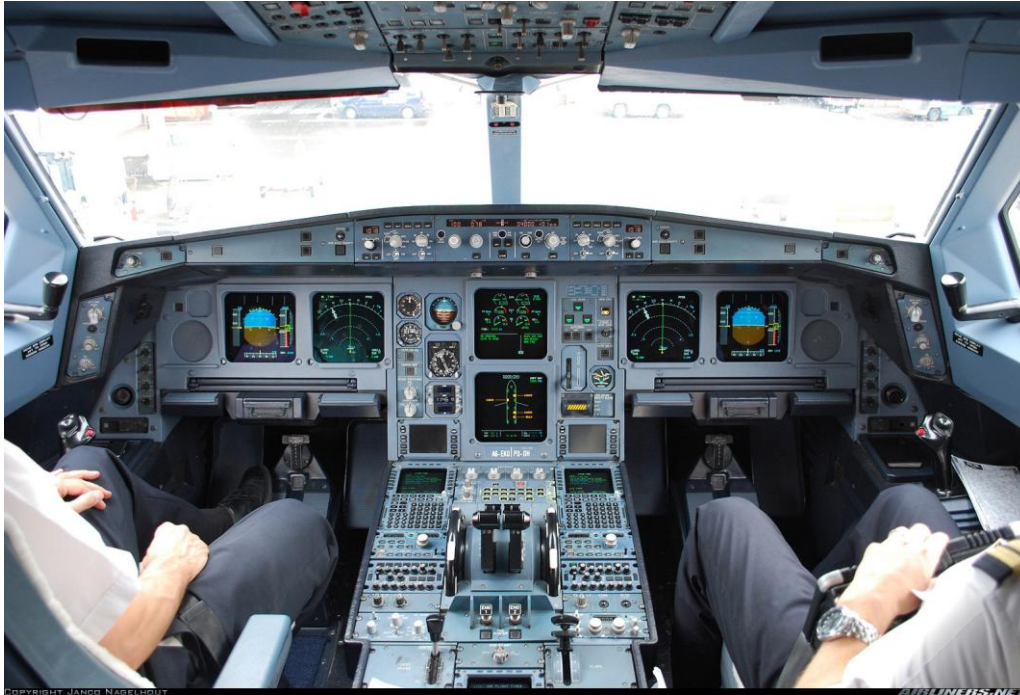
A pilot’s training is always that, in reaction to an approach to stall, the controls should be pushed forward. Bonin kept pulling his control back. A key feature of the Airbus controls is that the pilots control the plane using small side sticks at their sides, almost like games controllers. The right hand pilot’s control stick is on the right hand side, and the left hand pilot’s control stick is on the left hand side. The two pilots’ sticks move independently, so the pilot on the left hand seat cannot feel what the pilot on the right hand seat is doing. Furthermore, it may not be clear to the non-flying pilot what inputs the flying pilot is making because small wrist movements are enough to cause a control input. Robert will, presumably, have been looking at the instrumentation and not at Bonin’s right hand.

11-4: Airbus A330 cockpit showing the positions of the control sticks for the two pilots, on the extreme right and extreme left. ([www.airliners.net](http://www.airliners.net))
