Whatcom Falls Park pipeline rupture, 10 June 1999

Jim Thomson

EM&I, 12 November 2015

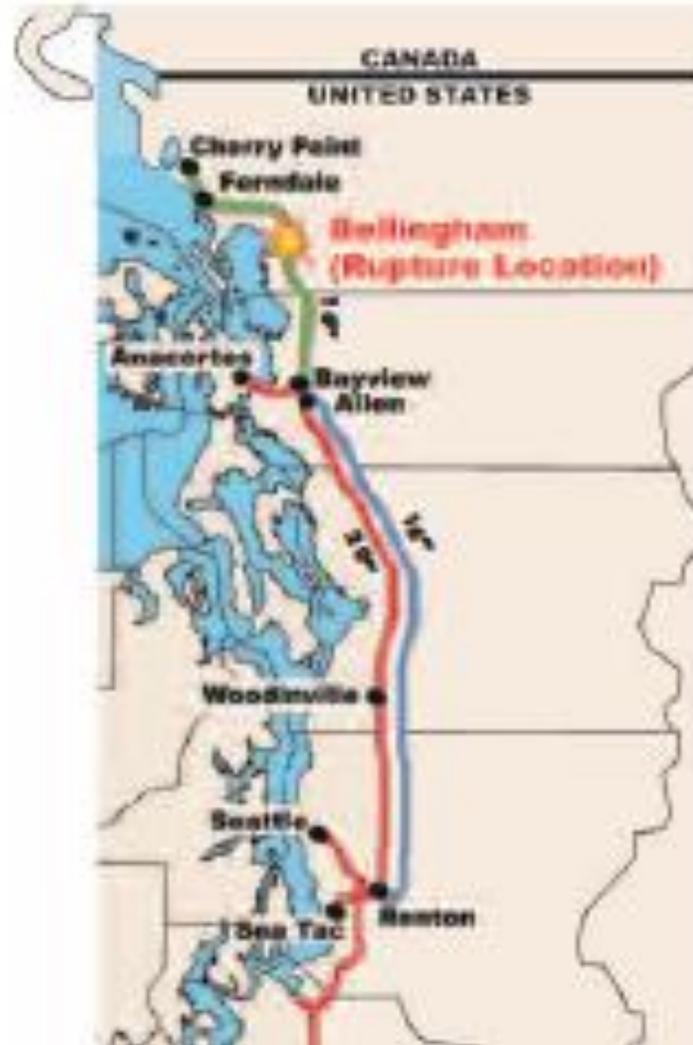
Figure 2. Olympic Pipe Line Company system.

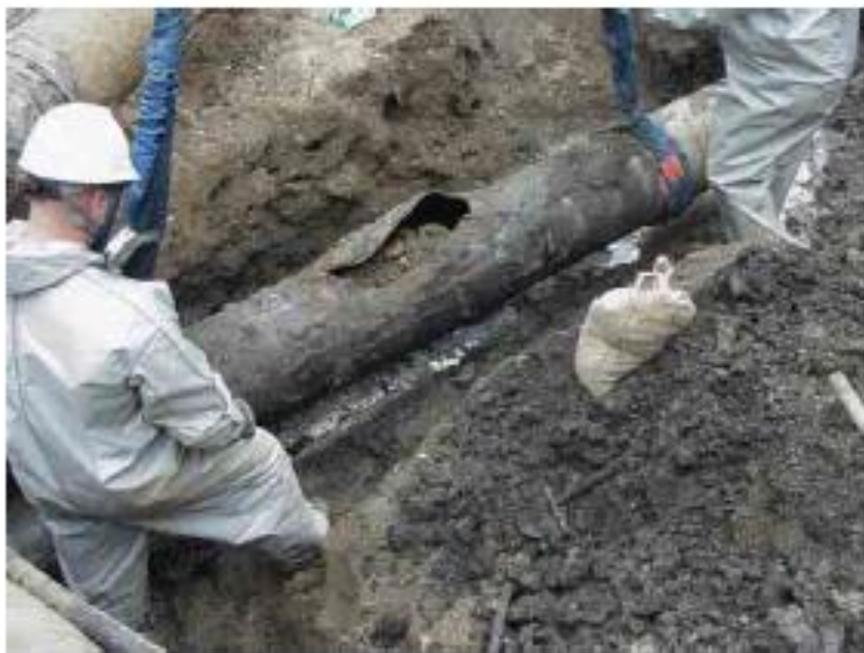
Figure 10. Removal of ruptured pipe section.

The result of all the above was that a pressure pulse occurred, but the relief valve had never worked, and the control system was unresponsive, so the isolation valves did not operate. The pipeline pressure rose and the pipe ruptured at the defect caused by the excavation damage in August 1994, allowing one million litres of gasoline to flow down a river creek on a summer afternoon, where it caught fire and killed three people.

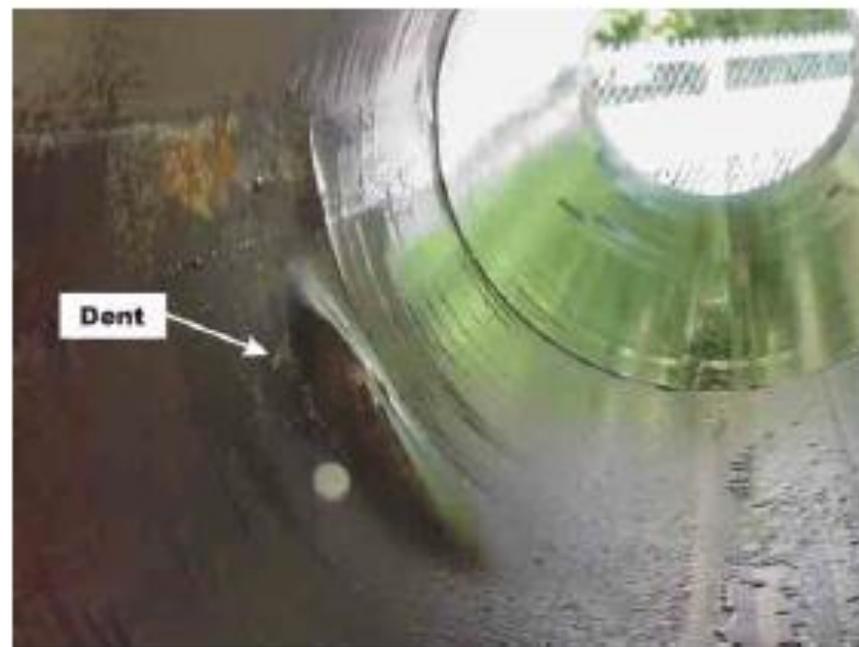
1. The pipeline was damaged during excavation work carried out IMCO probably on 11th August 1994.

*Excavation around the Olympic pipeline occurred in August 1994, without Olympic inspectors being present, in order to lay a new water pipeline which crossed over the gasoline pipeline. **A subcontractor to IMCO told the accident investigators that he heard the gasoline pipeline being struck by a backhoe - a powered mechanical excavator - during the project, probably on 11th August 1994, when an Olympic representative was not present, and that IMCO personnel decided not to notify Barrett or Olympic.***

Figure 12. Inside view of second removed pipe section showing dent.

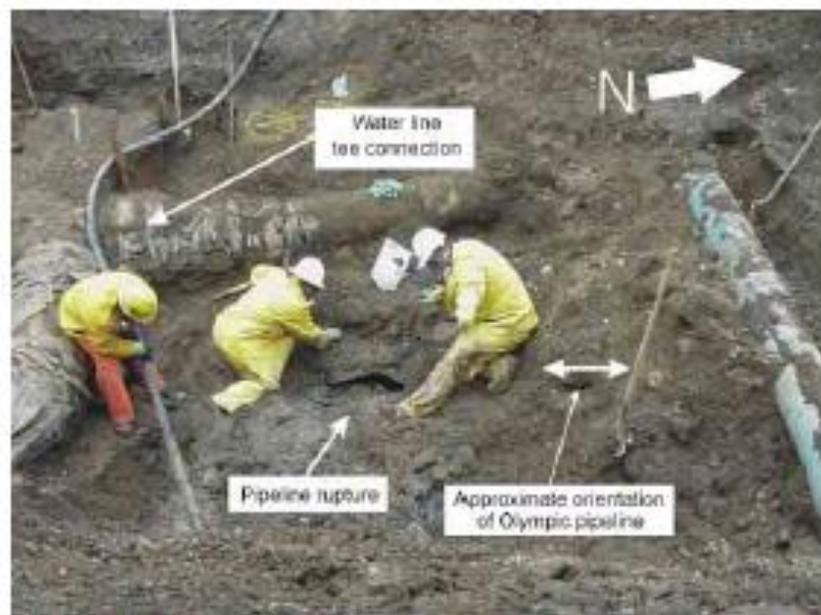
Figure 13. Rupture location before removal of pipe showing proximity of water line tee connection.
