Learning from Ignorance – Pressure Vessel Failures since the 19th Century

This note presents a brief history of pressure vessel integrity from the first Industrial Revolution to the present day.

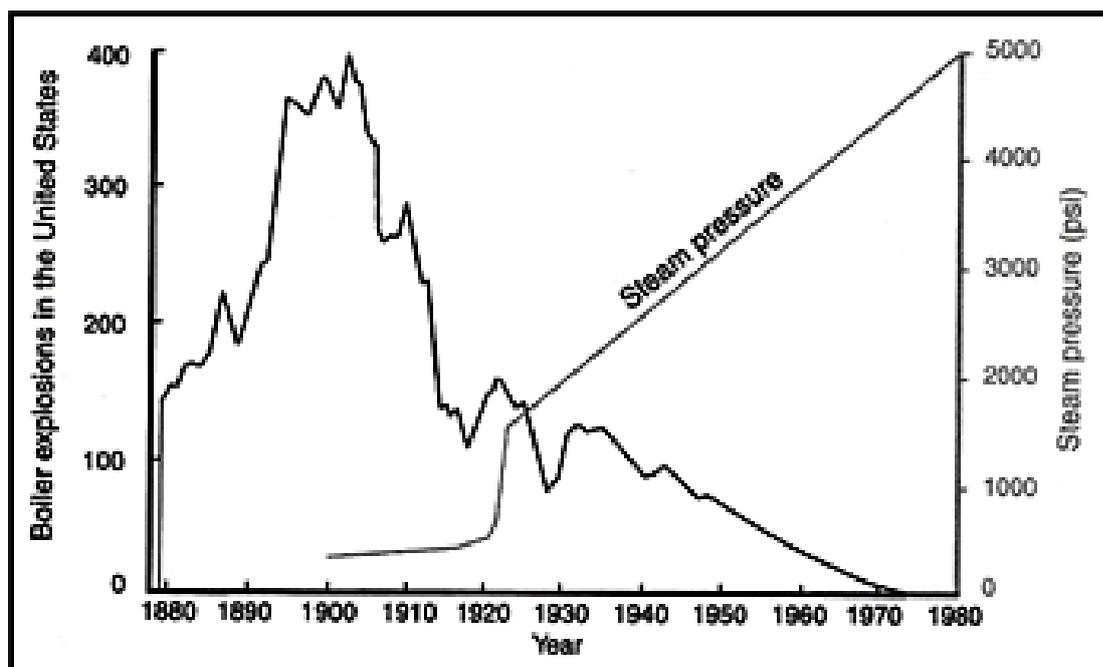
Fig 3: Rates of boiler explosions in the USA (TWI): This graph shows how improved design, a better understanding of the mechanisms causing failure, and better operation, maintenance and inspection regimes, led to a dramatic drop in the rate of boiler explosions. This reduced rate of explosions reached effectively zero by about 1970, despite steam pressures increasingly dramatically to achieve improved process efficiency.

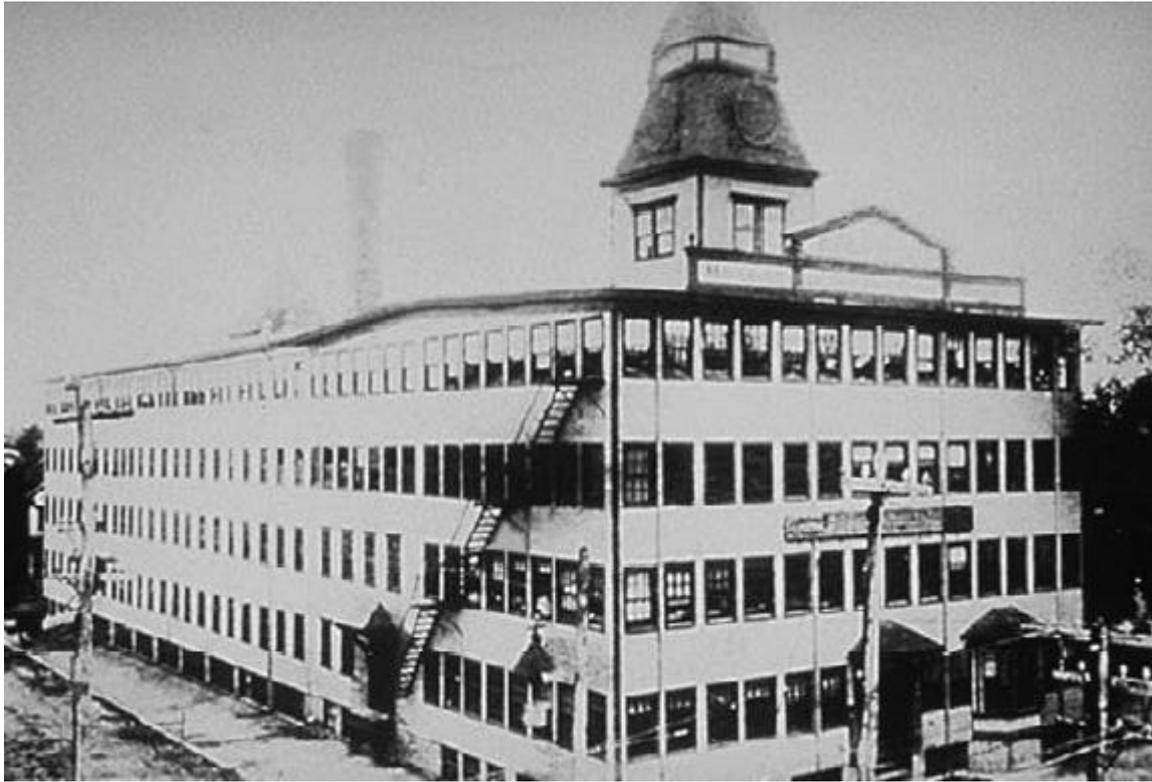
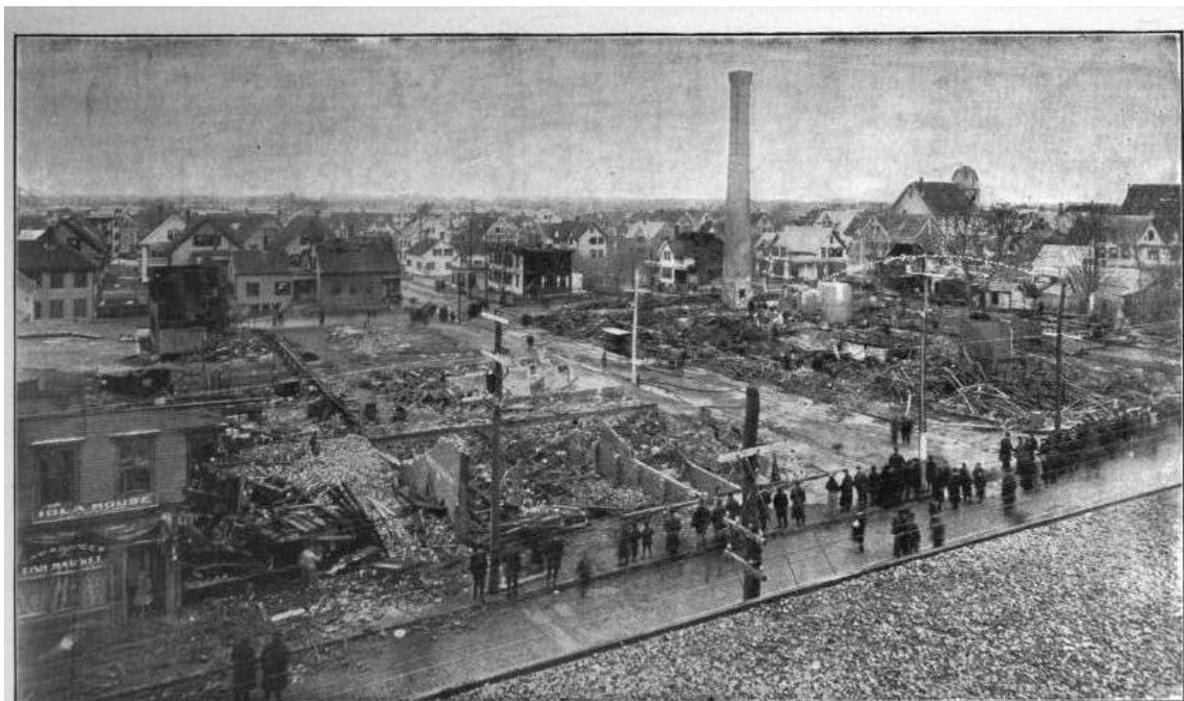
AFTER THE EXPLOSION AND FIRE. Looking west. Smokestack and ruins of Grover Factory at right; Dahlborg Block at left; ruined dwellings in background. Curved white line shows path of boiler from base of smokestack to house of Miss Pratt, where it lodged.  
View from Churchill & Alden Shoe Factory on east side of Main Street.

Fig 5: The boiler explosion at the Grover Shoe Factory, Brockton Massachusetts, on 20<sup>th</sup> March 1905. The only constant in these 'before and after' photographs is the chimney at the rear. This explosion in particular led to the development of the ASME Boiler Code.

Another massive boiler explosion occurred at 0750 hours on 20th March 1905. It killed 58 people and completely destroyed a four-storey building, the Grover shoe factory ('Makers of the Emerson Shoe') located on the corner of Main and Calmar streets in the largely Swedish neighbourhood of the Campello section of Brockton, Massachusetts. The explosion was due to the failure of an old boiler which was used as a backup during maintenance on a newer model. The boiler rocketed through three floors and the building's roof, and broken beams and heavy machinery trapped many workers who survived the initial explosion and collapse. Burning coals thrown from the boiler landed throughout the crumbling superstructure, starting fires that were fed by broken gas lines.

Mr. French said he believed it proved that the explosion was due to a hidden defect in the factory boiler. The witnesses examined included a representative of the Grover Company, who testified that the boiler was inspected in December, and that there was no knowledge that it was not in good condition. Several Boiler Inspectors said that they had found a crack in the boiler, which was of obsolete type. Several factory employes declared that David W. Rockwell, engineer in charge of the boiler, who was one of the killed, seemed capable of attending to his duties on the morning of the accident.

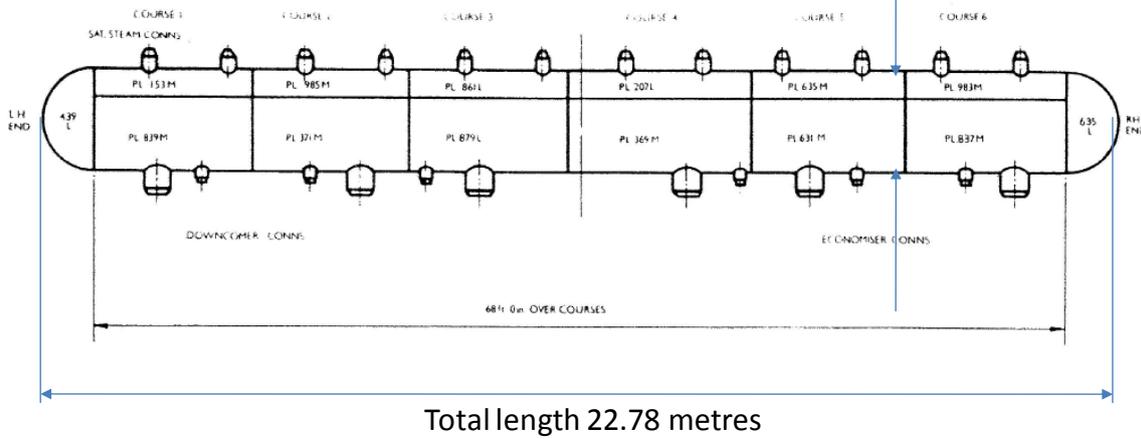
Wall thickness 14.13 centimetres  
 Weight 164 tonnes  
 Material 'Ducol' mild steel

Diameter 1.67 metres

The Cockenzie Steam Drum before failure

The Cockenzie steam drum failure of 6<sup>th</sup> May 1966 happened during the final, seventh cycle of hydraulic pressure testing before the steam drum would have been declared ready for service. It failed adjacent to one of the 'economiser nozzles', the transition pieces to the high-pressure pipes that, in operational service, would have led water from the underside of the drum to the boiler tubes. (See Figure 4-7.)

The economiser nozzles had been welded into the main pressure vessel using manual metal-arc welding. However, one of the economiser nozzles was found to be defective during inspection at works, and it was removed (by 'hand chipping and grinding') and replaced. A replacement nozzle was welded into place using the same procedure. The welds were inspected using magnetic particle inspection and reported clear of defects.

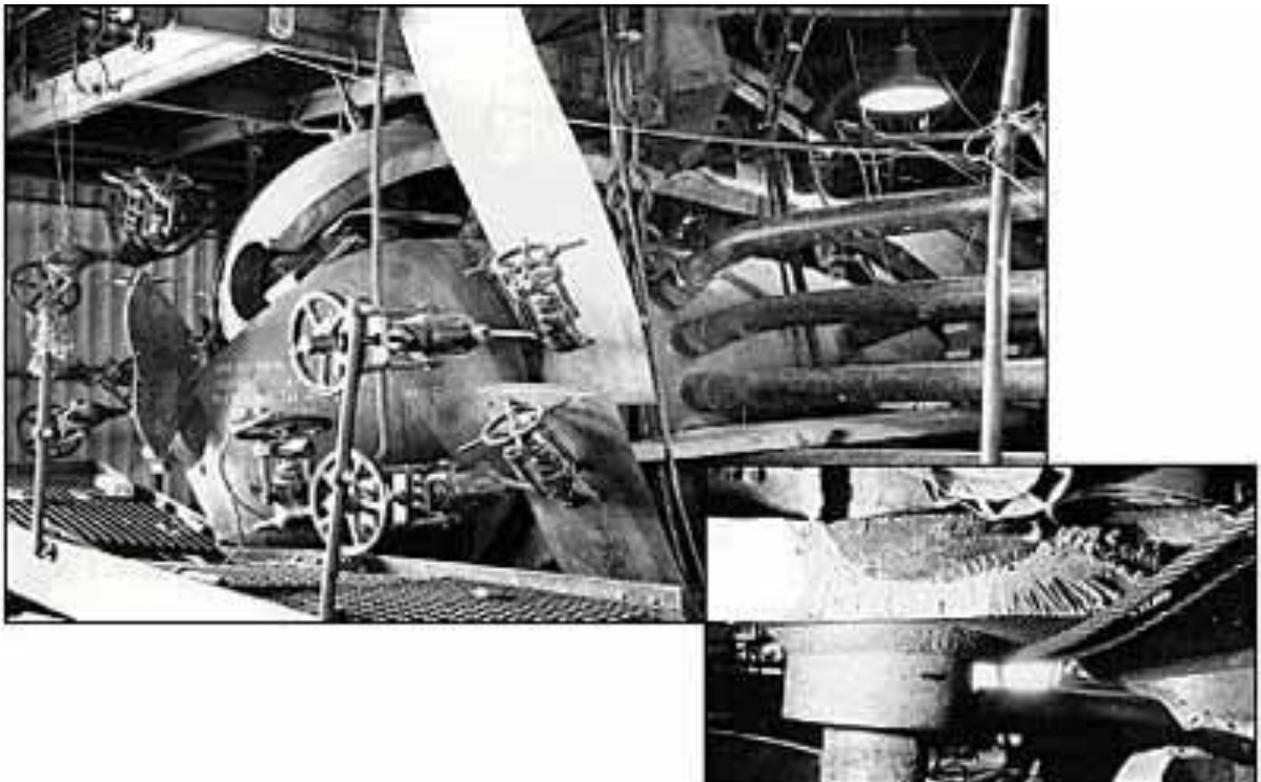
Fig 7: The Cockenzie Steam Drum after failure, with the failure site (inset). The dark tarnished area shows that the crack already existed during final heat-treatment, because the crack surface had discoloured.

The failure was caused by a crack next to the replaced economiser nozzle, created during the manufacturing process, which had penetrated part-way through the thick wall of the pressure vessel. The report does not reach definitive conclusions about the exact cause of the crack, but it suggests that it could have been caused by differential expansion created during the heat-treatment process. The crack, which was 33 centimetres long and 9 centimetres deep, must have been there during at least part of the heat-treatment, because its surfaces had been tarnished by the heat treatment (as can be seen in the photo).

It was this replacement nozzle where the drum failure originated.

The failure occurred during the drum's seventh cycle of pressure testing, at about 3980 psig, on 6<sup>th</sup> May 1966 at Cockenzie. The drum was filled with approximately 48 tonnes of water at about 8 degrees Centigrade. A large portion, about five metres long and at its maximum almost the full diameter of the drum, suddenly broke away, releasing the water onto people working underneath. The report notes laconically that "The deluge of water caused fright and shock to a number of men.....but there were no serious injuries." There will also have been a very loud bang when the drum failed.

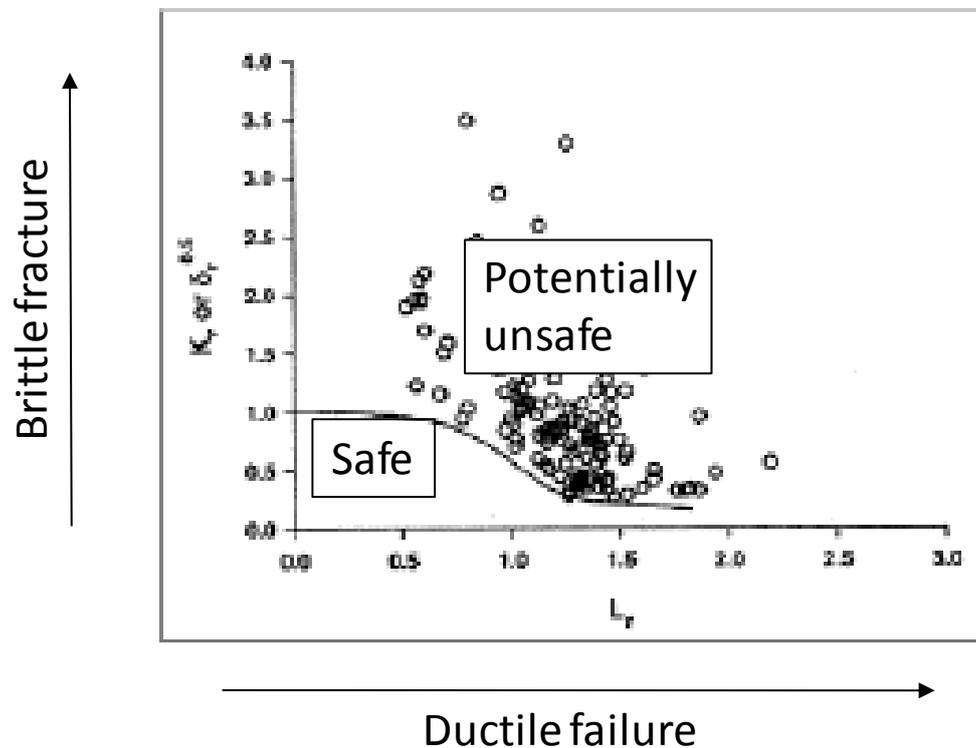
Fig 8: A Failure Assessment Diagram for the R6 method. A point on the graph can be plotted corresponding to a known defect. The points are experimental results where failure occurred – the key requirement to validate the R6 method is that no failure should occur on the side of the line labelled 'safe'.

About the same time as the Marshall Report, a method for the analysis of a pre-existing defect, to determine whether it would cause either ductile failure or brittle fracture, was developed by the UK Central Electricity Generating Board, called the R6 method<sup>13</sup>. This technique was a development of earlier methods but can still be thought of as a breakthrough. It has now been further developed and is in wide use. The R6 method uses a *Failure Assessment Diagram* developed from a combination of theoretical and empirical work. The original R6 Failure Assessment Diagram was a combination of Griffith crack equation and the BCS model, which were discussed above. (Later versions have refined this somewhat.)

The R6 methodology enables the integrity of pressure vessels to be validated, using a technique that is underpinned by science. R6's prerequisites are that reliable, verifiable data about material properties and stress distributions have to be available, and that all significant defects in the metal have to be identified and measured. The R6 methodology generates a line on the Failure Assessment Diagram (Figure 4-8) which gives a lower bound to all ductile or brittle fracture, regardless of detailed crack geometry, which thereby enables the avoidance of failures.
