Whatcom Falls Park pipeline rupture, 10 June 1999

Jim Thomson

EM&I, 12 November 2015

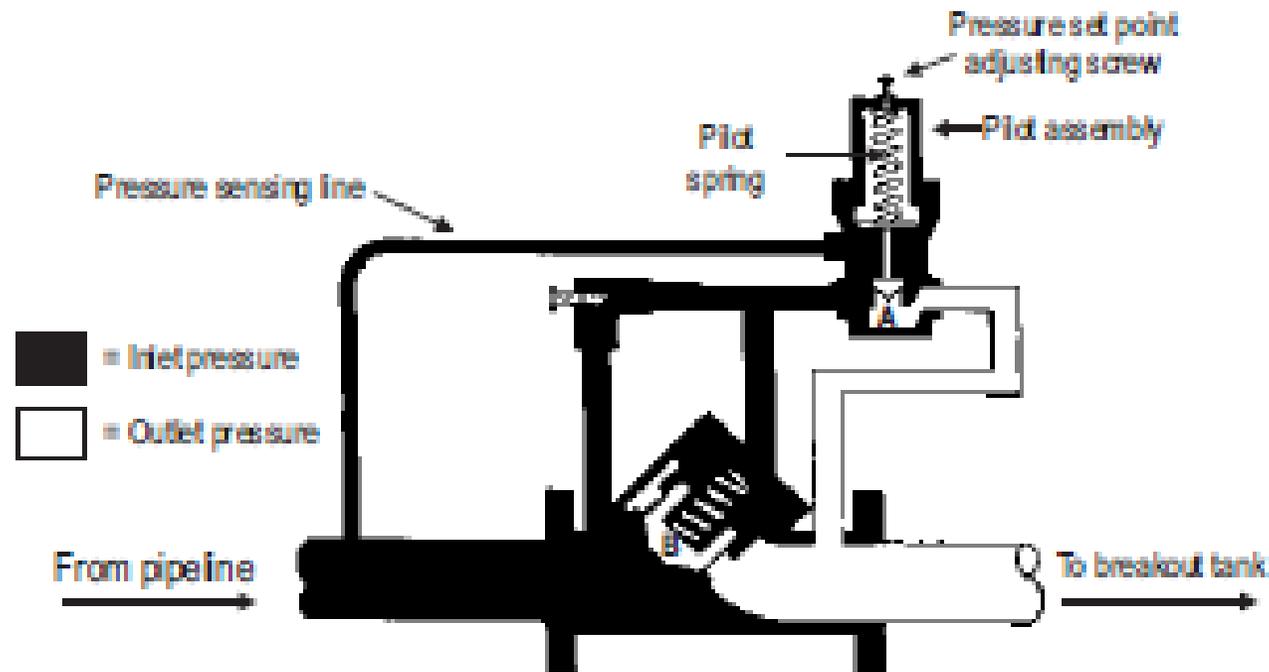
6. **The pressure relief valve was not set up properly so it did not function, and it was not tested so the improper set-up was not revealed.**

7. Because the relief valve was not opening when required, there were **41 separate occasions when the isolation valves operated because of overpressure. None of these was investigated.**

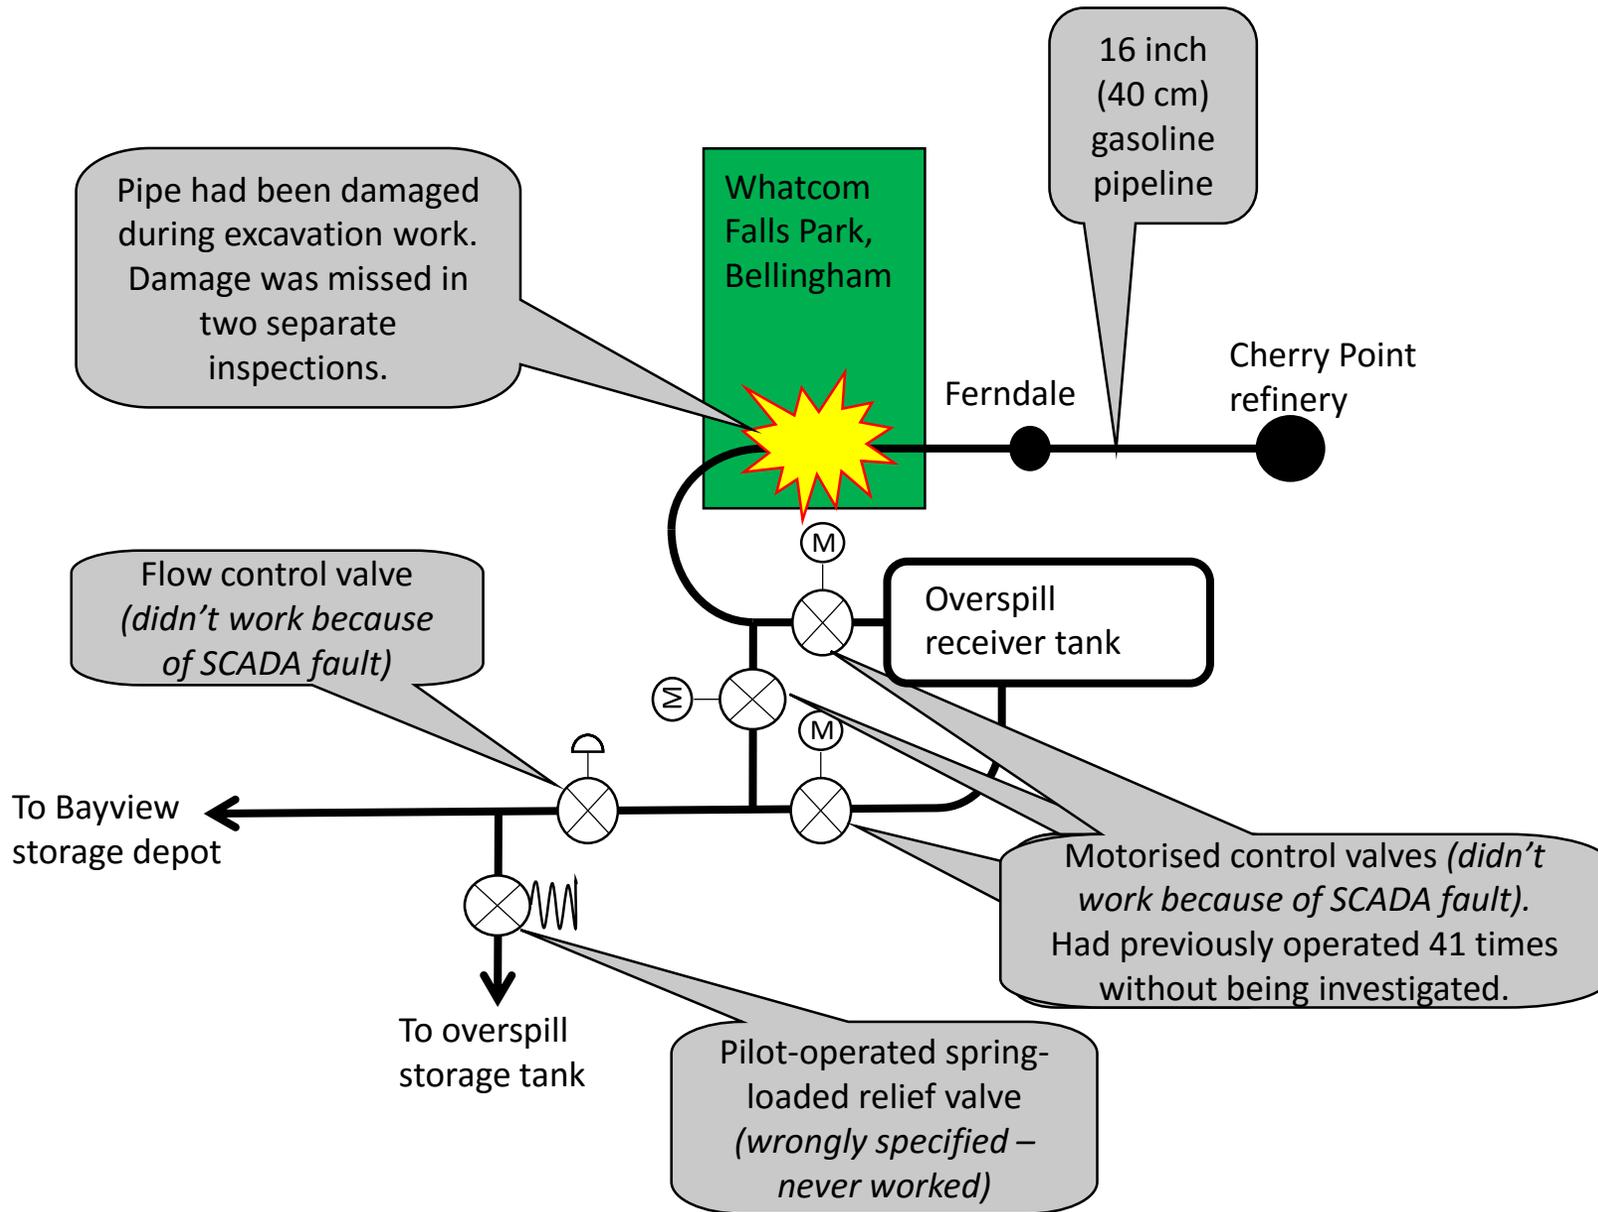
The result of all the above was that a pressure pulse occurred, but the relief valve had never worked, and the control system was unresponsive, so the isolation valves did not operate. The pipeline pressure rose and the pipe ruptured at the defect caused by the excavation damage in August 1994, allowing one million litres of gasoline to flow down a river creek on a summer afternoon, where it caught fire and killed three people.
